Gardner Denver Nash Failure Analysis

Failure Due to Calcium Buildup

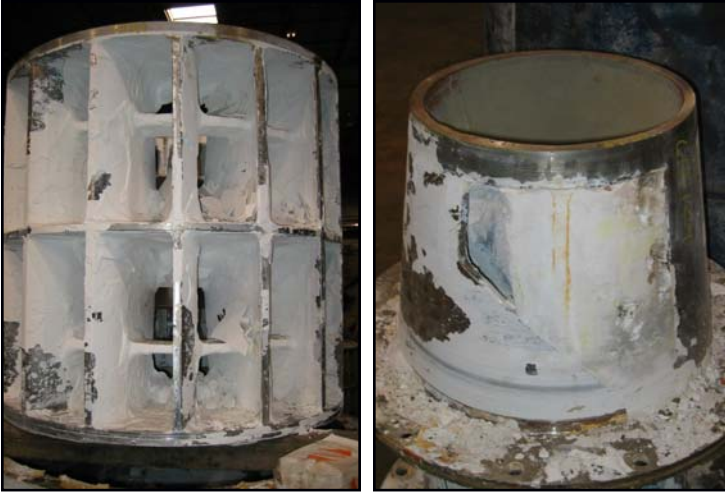
Calcium coated rotor and cone

Calcium (aka Lime) build up can cause higher horsepower consumption, reduction in pump capacity, lost production time due to locking up of the pump, and pump damage due to improper acid washings

- “Hard” seal water source (containing high concentrations of calcium carbonate)
- Recirculated seal with increasing levels of calcium carryover
- Hot seal water

- Liquid carryover from process containing calcium
- Vapor carryover from process

- Poor acid washing practices
- Waiting too long to properly acid wash pumps
- Pump lockup

- Change seal water source
- Recirculate seal water
- Treat seal water
- Avoid hot seal water via cooling tower

- Install separators and/or eliminate calcium source
- Install spray nozzles with cool seal source

- Follow Nash acid washing procedures (could cause corrosive attack if not done properly)
- Monitor buildup via Nash borescope
