Gardner Denver Nash Failure Analysis

Failure Due to Corrosion

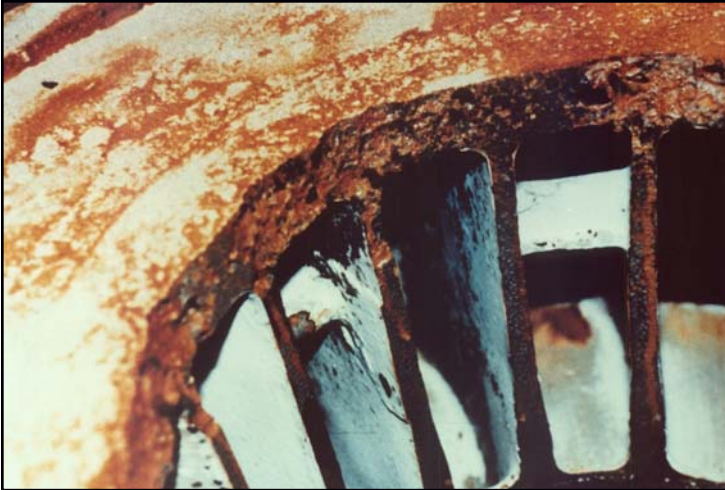
Corroded Rotor Taper

Corrosion can be caused by low pH seal water or carryover, and can reduce pump life cycle dramatically

Possible Causes

Seal Water

- Low pH seal water
 - Recycled seal water with low pH build up
 - Seal water mixing with corrosive carryover, forming a corrosive mixture
- Example: $\text{H}_2\text{O} + \text{SO (sulfur)} = \text{SO}_2$

Carryover

- Vapors from inlet gases can cause corrosion

Acid Washing

- Improper acid washing procedures

Possible solutions

Seal Water

- Maintain correct pH level of 7
- Maintain and treat seal system
- Stop corrosive carryover

Carryover

- Eliminate gases source
- Neutralize gases before entering pump

Acid Washing

- Follow Nash acid washing procedures
